Note: The Rescue Sheet depicts a LHD vehicle (as allowed under the ISO 17840-1). All components (other than steering wheel and passenger airbag) are located in the same position in the Aust/NZ RHD model.

1. Identification / recognition

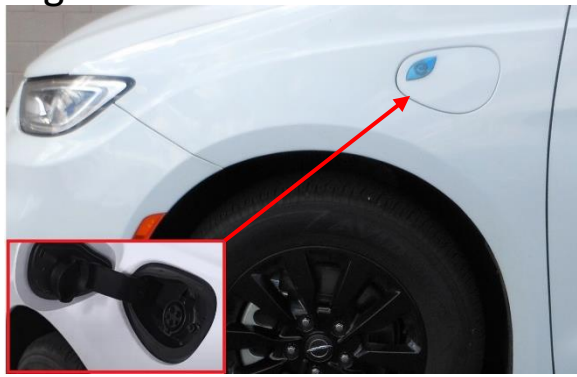
Charging port door with “e” leaf logo on left side:

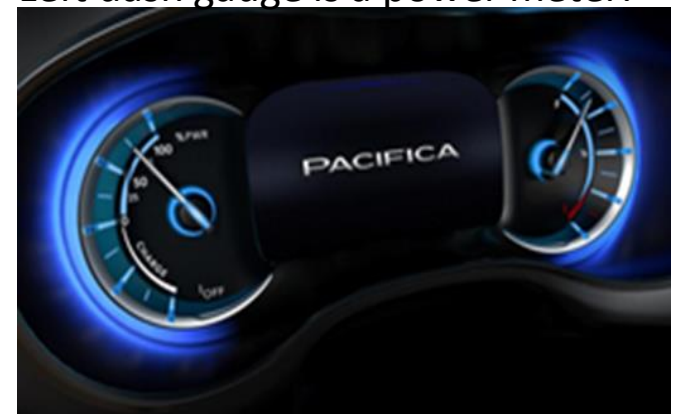
Left dash gauge is a power meter:

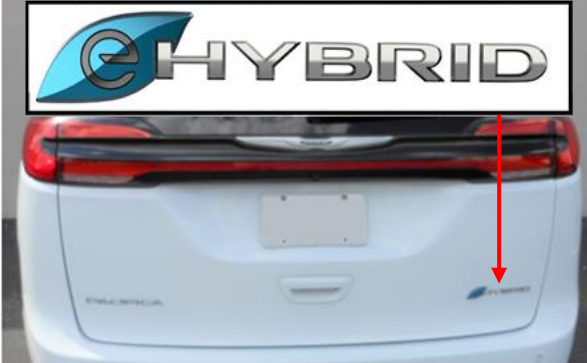
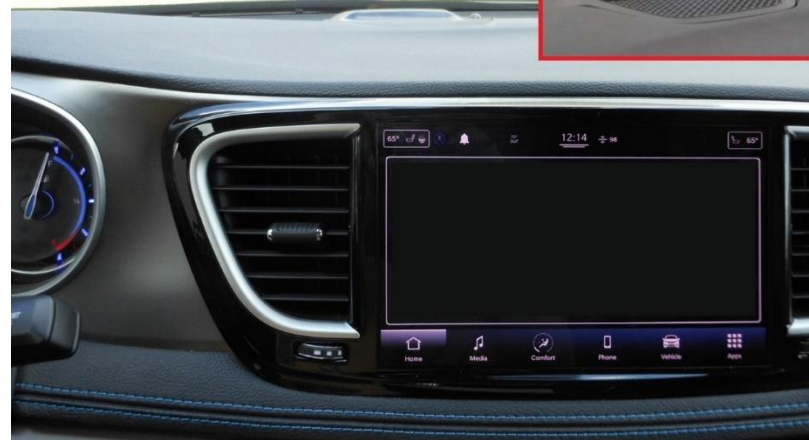
Badge rear lift gate right corner:

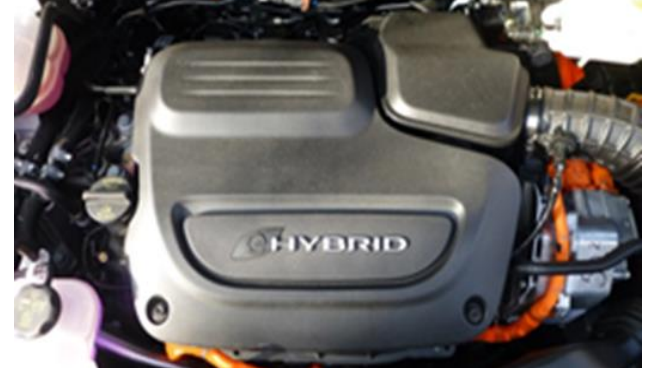
Unique engine cover:

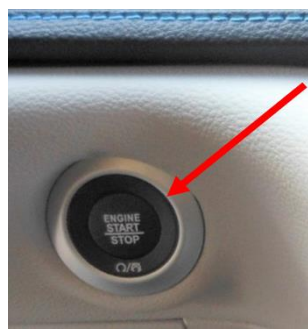
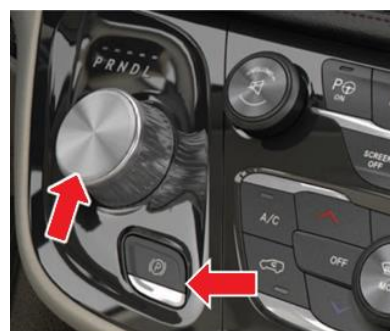
1. Set ignition to “RUN” or “ACC”
2. Place Shifter in Park (rotate counterclockwise)
3. Set Parking Brake by pulling up on switch

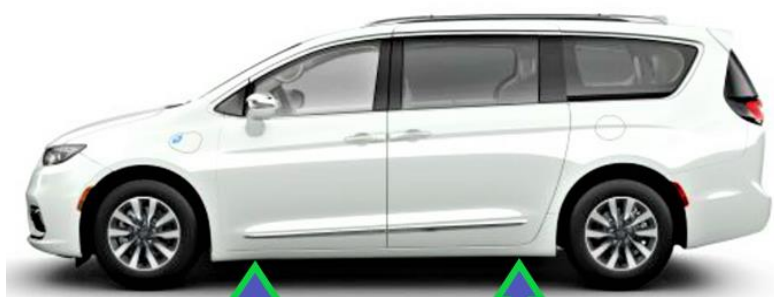
Recommended Lift Points

Stabilisation/lifting points

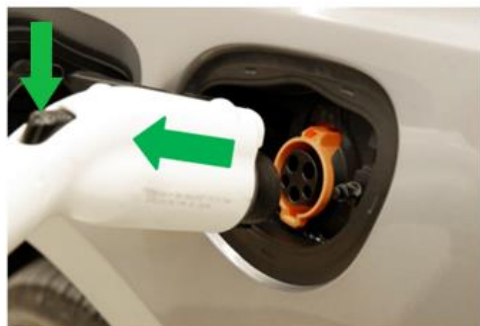
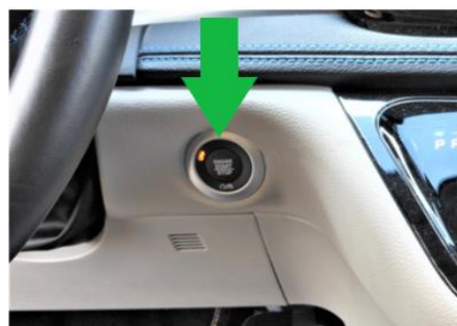
1. Unplug from any charging equipment
2. Set Ignition to OFF
3. Move key fob at least 6 meters (20 feet away)
4. Open hood
5. Cut a segment of cable away at the responder cut tape

First Responders Label as seen in vehicle

This disables high voltage and some low voltage **including restraints**

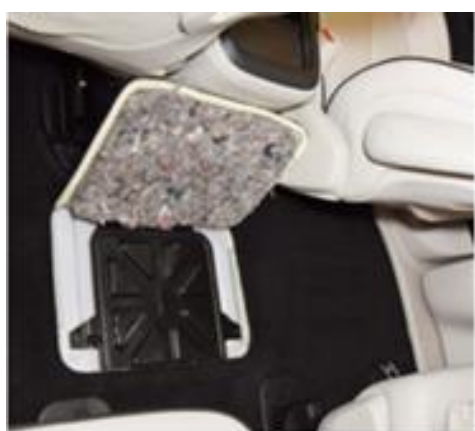
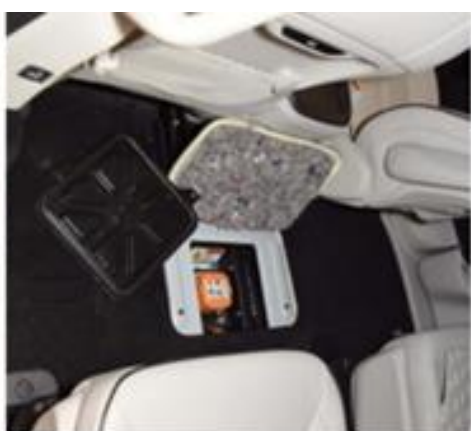
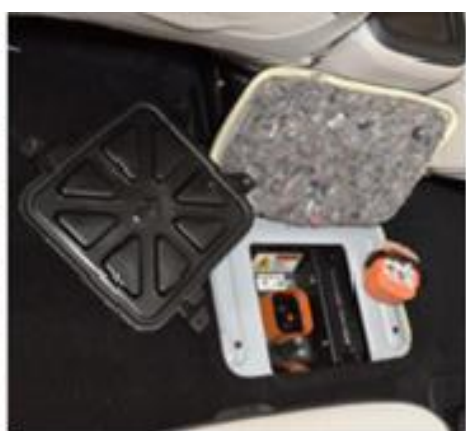
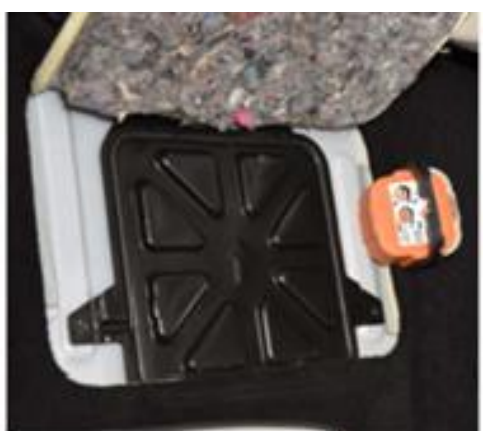
The Service Disconnect cover is located between the 1st and 2nd row seats.

1. Uncover Service Disconnect access cover
2. Unbolt the cover panel
3. Remove the Service Disconnect
4. Reinstall the cover over the empty socket

This method disables high voltage, but **NOT LOW VOLTAGE**—**restraint systems will remain powered.**
